Manhole Inspection Summary

Manhole # S65O__015MH

Insp Date: **2/8/08 1:09 PM**

Location Address: **6123 Toone St.**

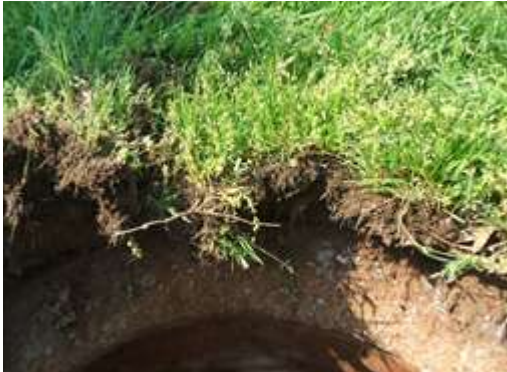
Defect 1

Cover Shape: **Circular** Diameter: **24** (in.) Length: (in.) Dist A/B Grade: **-2** (in.)

below grade

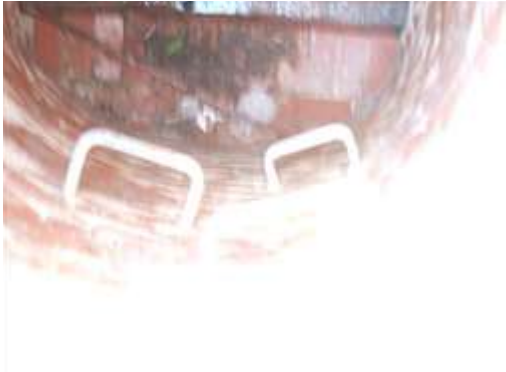
Defect 2

Condition: ☐ Sound ☐ Cracked ☐ Root Intrusion ☐ Deteriorated ☐ Leaks ☒ **Debris**

debris

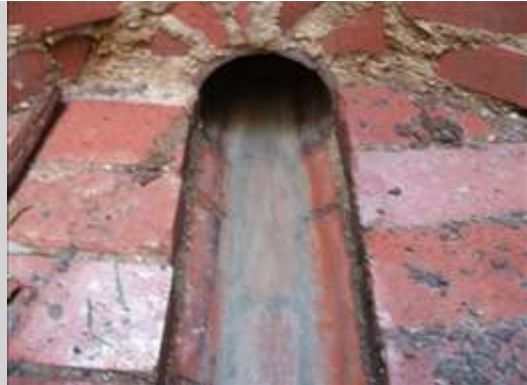
12 O'Clock Outflow

6 in. Circular Gravity Sewer
Pipe Out @ 12 O'Clock

Pipe Height: **6** (in.) Rod Only
Pipe Material: **Clay** ☐ Pipe Lined
Invert Depth: **6.30** (ft.) Flow Characteristics: **Slow**
Deposits: ☒ None ☐ Mud ☐ Sludge ☐ Debris ☐ Grease
Silt Depth: (in.) Deposits Extent:
Infiltration: **None** Pipe Seal Cond: **Sound**

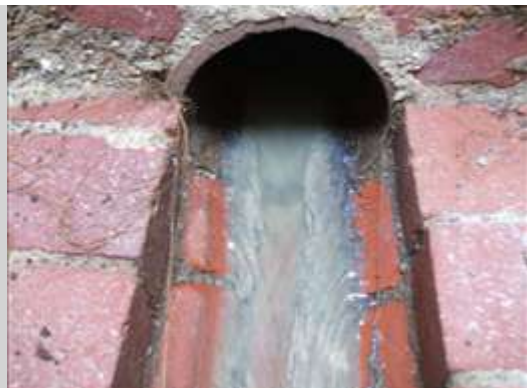
6 O'Clock Inflow

6 in. Circular Gravity Sewer
Pipe In @ 6 O'Clock

Pipe Height: **6** (in.) Rod Only
Pipe Material: **Clay** ☐ Pipe Lined
Invert Depth: **6.25** (ft.) Flow Characteristics: **Slow**
Deposits: ☒ None ☐ Mud ☐ Sludge ☐ Debris ☐ Grease
Silt Depth: (in.) Deposits Extent:
Infiltration: **None** Pipe Seal Cond: **Sound**
